# INSPECTION REPORT

Inspection Date: Sunday, May 3, 2026

House Whisperer Home Inspections  
318 Millbank Drive  
London, ON N6C 4W2  
519-852-7369

RE: Report No. 1221  
[REDACTED]  
[REDACTED]  
[REDACTED]

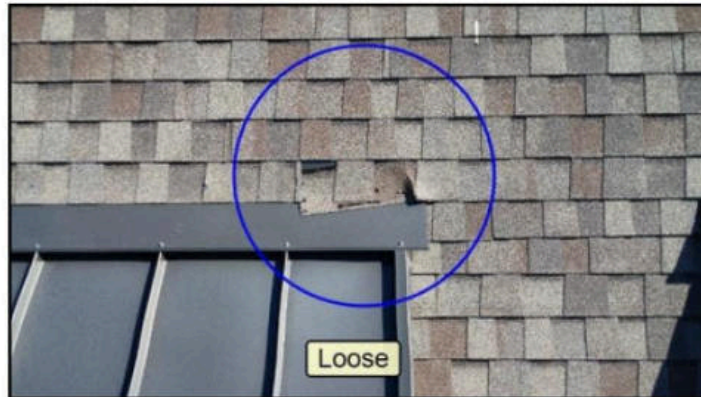
**2. Missing, loose or torn**

1. Condition: • [Missing, loose or torn](#)

Implication(s): Chance of water damage to structure, finishes and contents

Location: Front, above middle dormer

Task: Repair

Time: Immediately

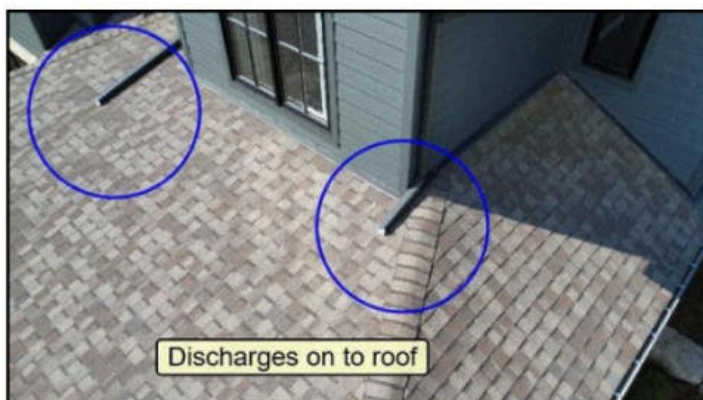
**3. Discharge onto roofs**

**2.Condition:** • [Discharge onto roofs](#)

**Implication(s):** Chance of water damage to structure, finishes and contents

**Location:** Back deck roof

**Task:** Provide extension

**Time:** Discretionary

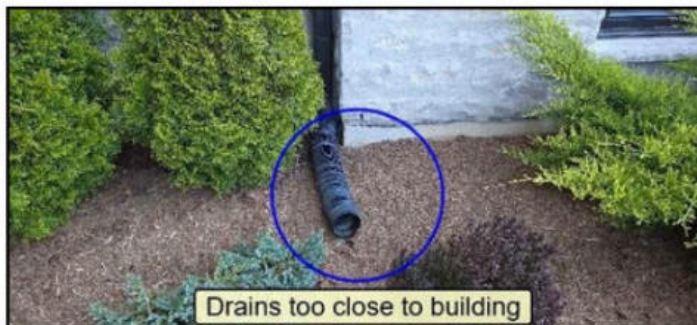
**5. Discharge too close to building**

**3.Condition:** • [Discharge too close to building](#)

**Implication(s):** Chance of water damage to structure, finishes and contents

**Location:** Front

**Task:** Have the extension drain further away from home

**Time:** Immediately

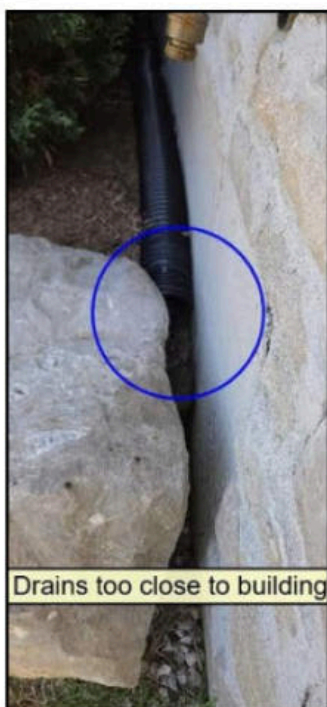
**6. Discharge too close to building**

**4.Condition:** • [Discharge too close to building](#)

**Implication(s):** Chance of water damage to structure, finishes and contents

**Location:** Front right side

**Task:** Provide extension

**Time:** Immediately

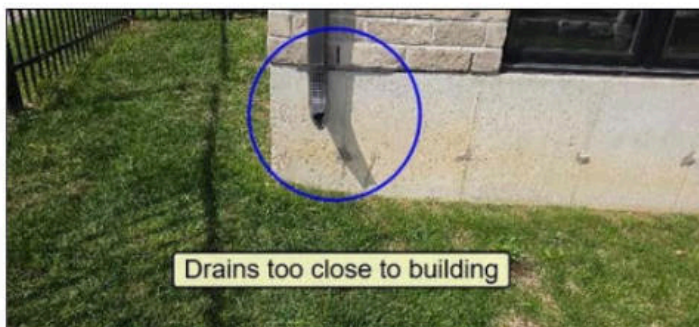
8. Discharge too close to building

**5.Condition:** • [Discharge too close to building](#)

**Implication(s):** Chance of water damage to structure, finishes and contents

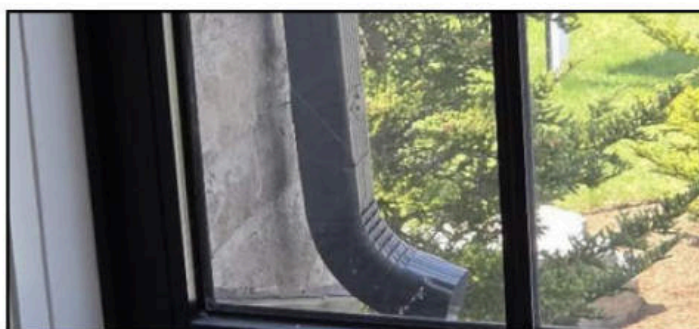
9. Loose

**Condition:** •

Screw came out of wall

**Location:** Front above entrance**Task:** Repair**Time:** Immediately

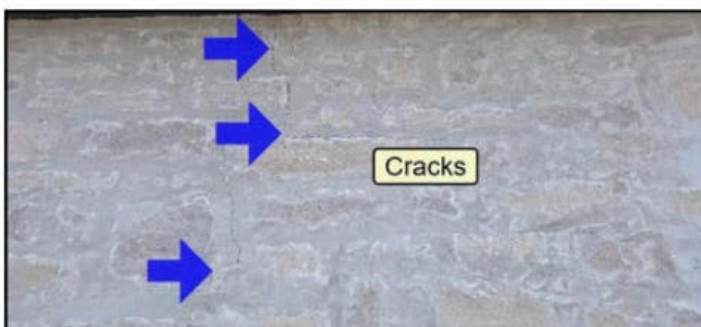
10. Cracked

**WALLS \ Masonry (brick, stone) and concrete****7. Condition:** • [Cracked](#)**Implication(s):** Chance of water entering building | Weakened structure | Chance of movement**Location:** Front over garage**Task:** Monitor**Time:** Ongoing

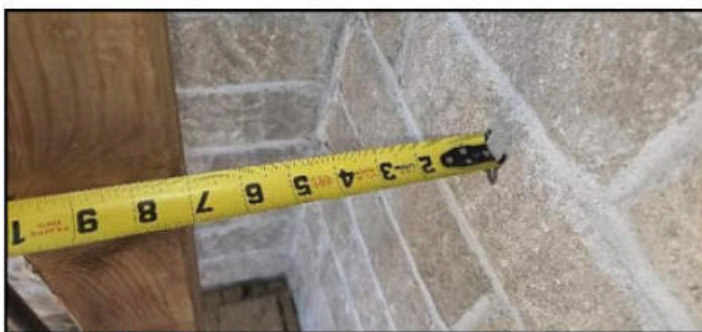
**12. Spindles (balusters) too far apart**

**PORCHES, DECKS, STAIRS, PATIOS AND BALCONIES \ Handrails and guards****8.Condition:** • [Spindles \(balusters\) too far apart](#)**Implication(s):** Fall hazard**Location:** Back deck main floor**Task:** Close gap**Time:** Before children use

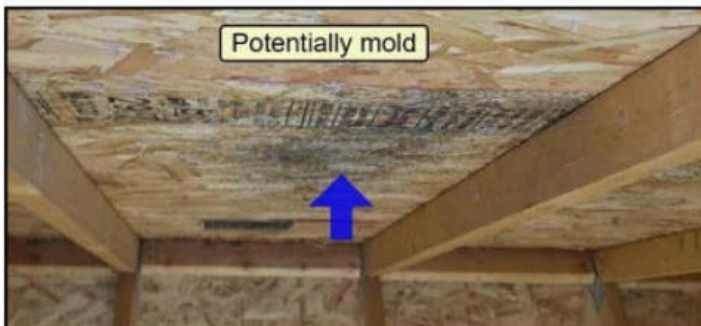
22. Mold

**9. Condition:** Mold

**Task:** Further evaluation needed

**Time:** Immediately

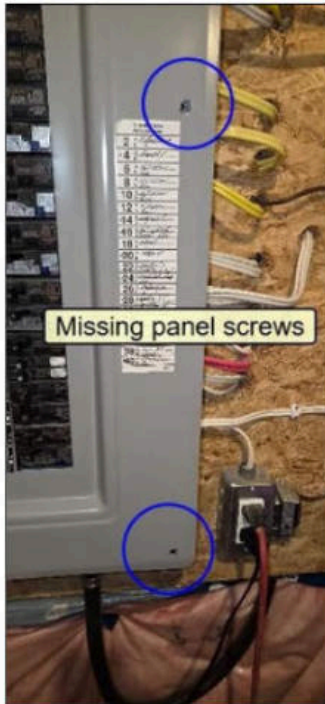
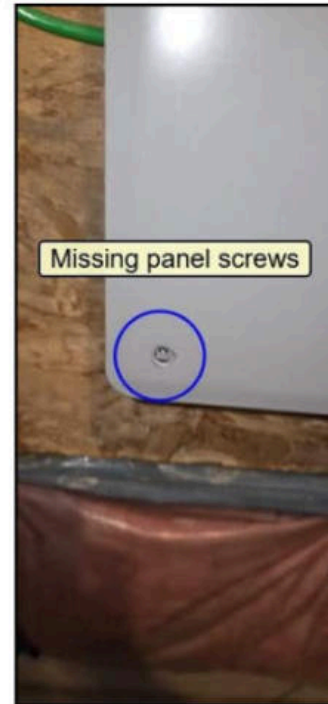
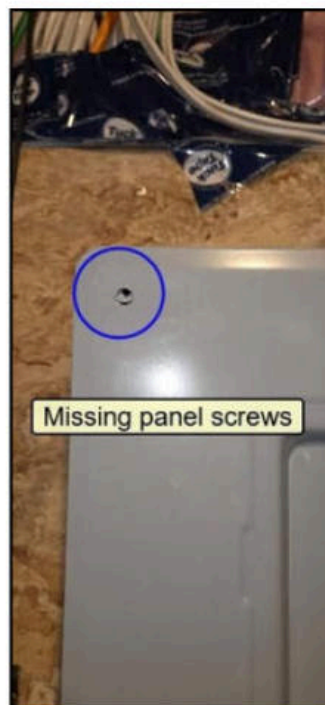
**10.Condition:** • Missing dead front panel screws

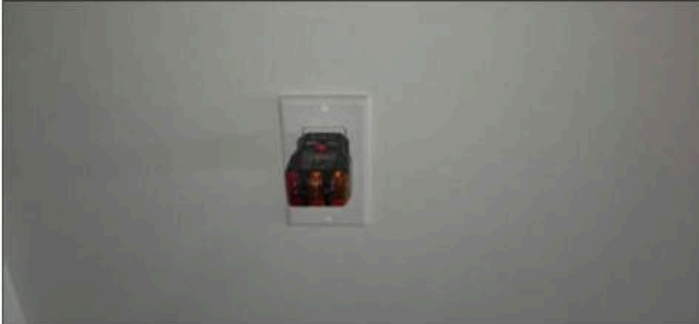
**33. Inoperative**

**DISTRIBUTION SYSTEM \ Outlets (receptacles)****11. Condition:** • [Inoperative](#)**Implication(s):** Equipment inoperative

**Location:** Left side of gym entrance doors**Task:** Further investigation needed**Time:** Discretionary

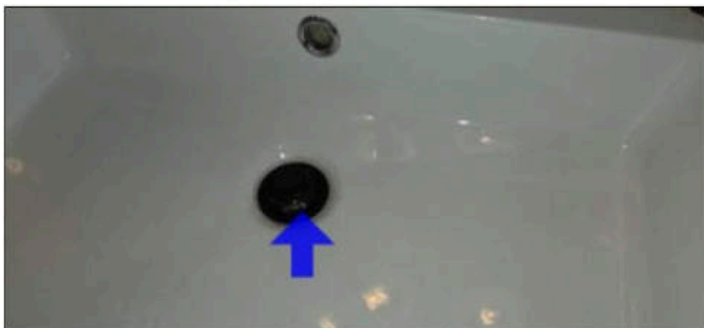
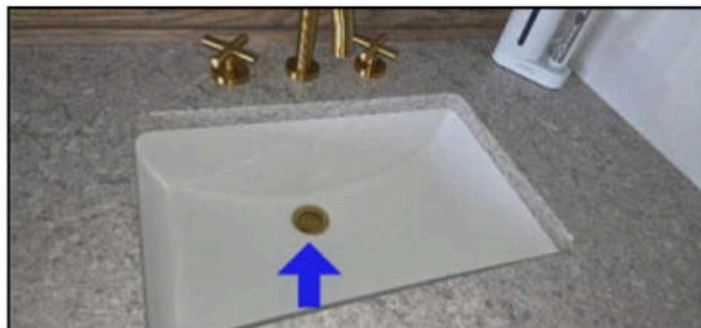
**FIXTURES AND FAUCETS \ Faucet****14.Condition:** • Drain stopper inoperable**Location:** Main floor bathroom, master bathroom right sink**Task:** Repair**Time:** Discretionary
